# Essex 3-litre V6

## FANCY AN ENGINE FOR A QUID?

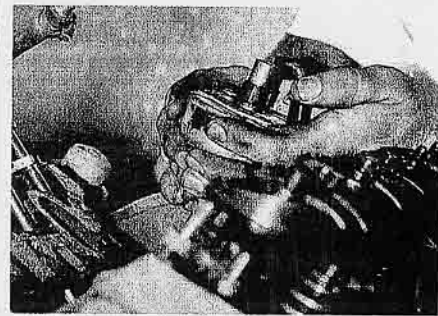
Distributor should lift out, but was stuck. Instead of using force, we left it until later.

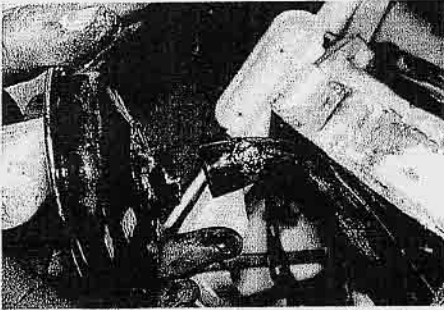
The oil pump was still a light grey colour rather than blackened like the crankshaft webs, which suggested that it hadn't been fitted long. Unfortunately, as we lifted it away the pick-up strainer fell off. This had clearly been broken in the past and soldered back

Previous soldered repairs to the oil pick-up strainer proved to be less than durable.

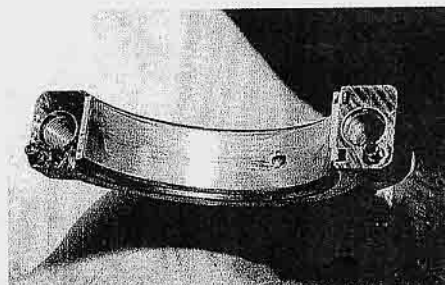
This big-end bearing was worn, but would have stayed quiet in a running engine.

The big-end bearings themselves and the crank journals beneath them looked in pretty good shape, with just some slight marking where specks of muck had been carried through in the oil. But when we took the front big-end bearing off, this was in considerably worse shape. The white lining material had worn away in places so that the copper backing below was showing. It might have already started knocking in this condition, and left to its own devices would certainly have started to do so soon. But if that one was bad, the rest were terrible, with virtually no lining material visible.

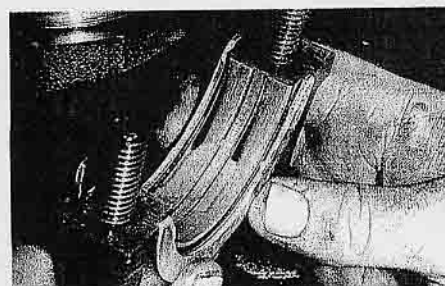
But the mains were a different story. Three of the four were completely shot.

Now for some more detective work. All the bearings were genuine Ford parts, the mains marked BA and the big ends CA. A quick check in an ancient parts book showed that these were standard size and 0.010 inch respectively. Always take the old bearings with you when ordering new ones because some engines had to be line-bored at the factory to correct minor errors, creating, in effect, over-size bearing housings. Put standard size bearings in these caps and the crank will wobble all over the place.

It is quite possible that the engine left the factory with these different-sized bearings fitted because manufacturers in the Seventies still found it cost-effective to re-machine faulty components. But it's also possible that someone splashed out on new pistons and grinding the big-ends journals, then saved a few quid by re-using the main bearings.

Dave is a bit more charitable and suggests a third possibility. With the fuel mixture being so rich, petrol washing down the bores could have diluted the oil, leading to new bearings failing very quickly. This observation is based on many years of bitter experience when customers have paid for a reconditioned engine, only to slap on the

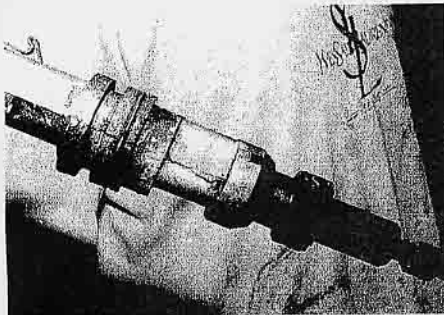
This crud on the distributor shaft was the reason why it wouldn't leave the block.

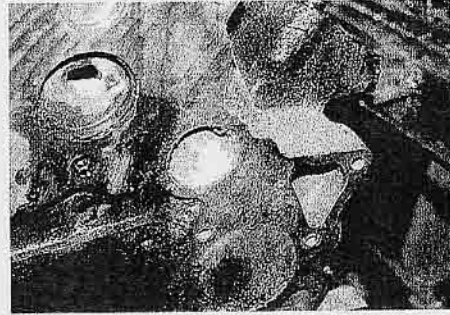
Rust points to previous water leak, but this shiny core plug had been replaced.

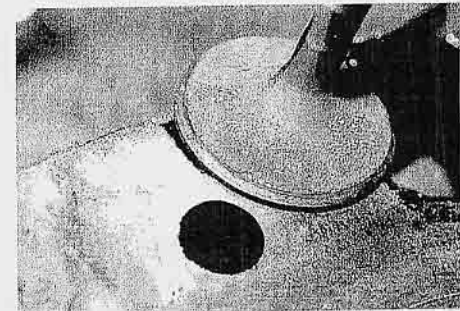
condition and seemed to be seating all right, but both they and the valve seats had a slightly rounded profile instead of a machine-fresh line at 45°. That suggested they had been lapped-in by hand in the past, but that the seats hadn't been re-cut. Wagging the valves in their guides showed that these were slightly worn, but not excessively so.

Seating face of valve is concave, so they've previously been lapped-in by hand.

If we were simply cleaning up the faces and re-using the valves, we could leave the guides alone. But we want to convert the heads to unleaded, which involves re-cutting the seats. Whenever you do this, you have to fit new guide inserts too because the cutting machine uses them to locate itself. If your guides are worn, your valves will end up off-centre too.

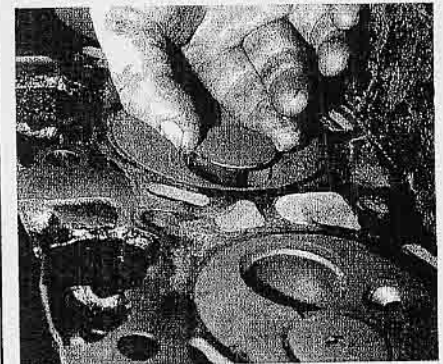
Rocking the valves in their guides gives a skilled engineer a quick test of wear.

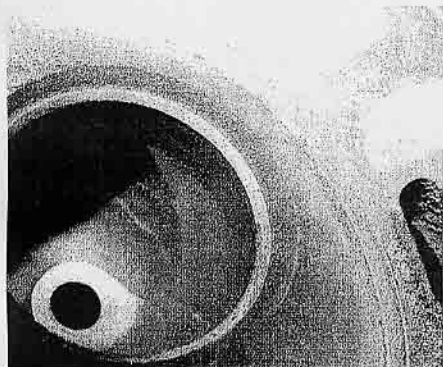
Minimal marking on valve seat faces, so they could have been lapped-in at home.

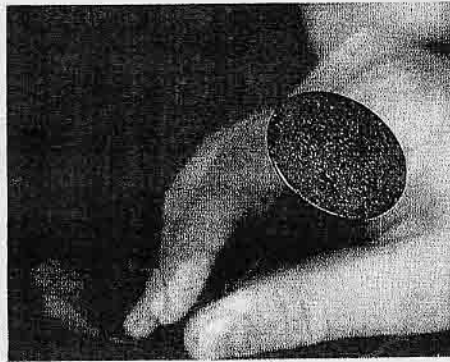
Pitting is from corrosion. We can re-use because seating face is sound and thick.

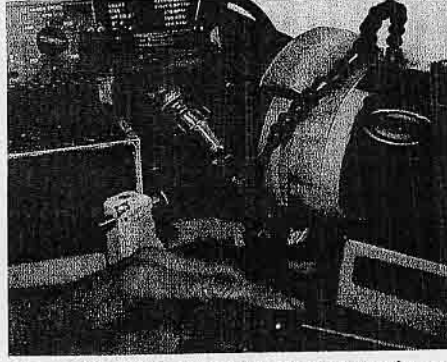
But seating faces must be re-cut to give a perfect seal where they meet new inserts.

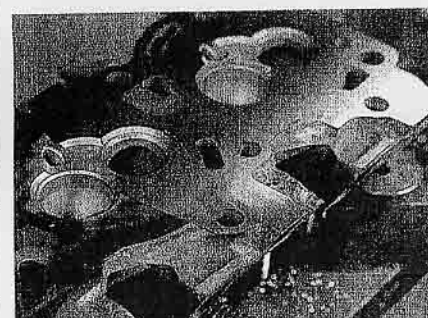
The final step with the heads is to check them for flatness. One of them had a 0.005in bow in the middle. There hadn't been any sign of blowing past the head gaskets, but often this sort of distortion is held in check by the head bolts and only gets released when they are undone. Dave took 0.006in off the head to clean it up, not enough to seriously affect the compression ratio. He also took the same amount off the other head, simply because it's good engineering practice to keep them even.

Finally, a skim takes care of distortion

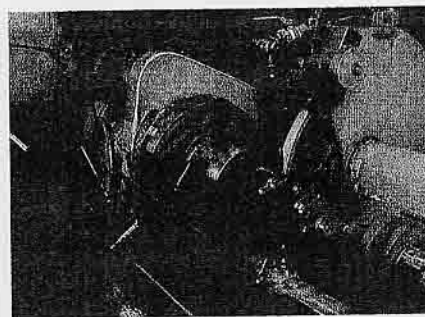
Grinding reveals how deep the scores are and what size bearing you'll need.

each journal and its bearing. This in turn lowers the oil pressure and, as insufficient oil gets forced between the surfaces, you end up with metal-to-metal contact and accelerated wear. Our main journals were obviously scored, a result of the shell bearings having been worn down to the copper backing. But the only way of knowing just how deep they went was to grind the journals back until they were clear and smooth.

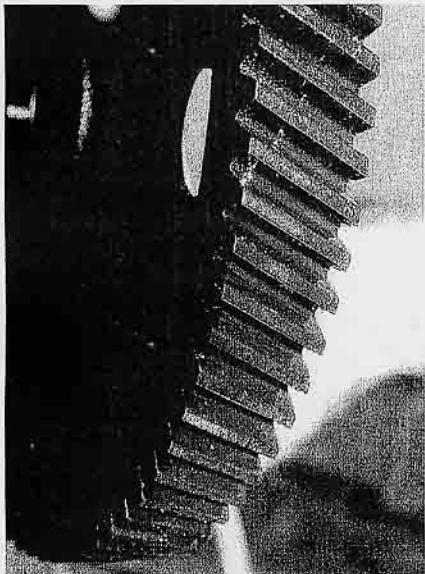
Sharp straight edges to timing teeth mean fibre wheel can be used again.

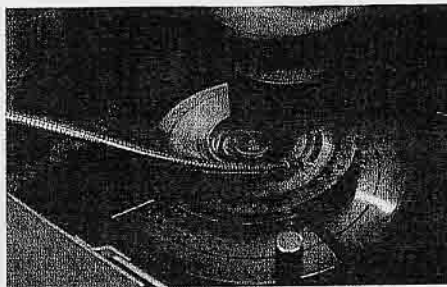
Wear rings become more visible during refacing, but ours needed minimal skim.

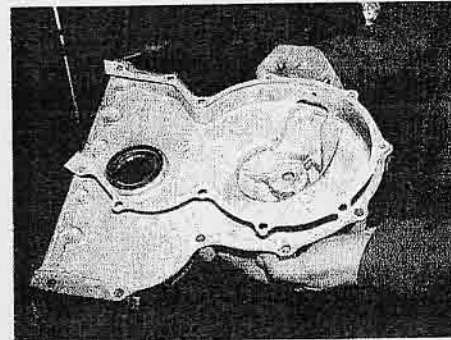
The wrong gasket? No, just an old one that had dried and shrunk in storage.
