# Essex 3-litre V6

## FANCY AN ENGINE FOR A QUID?

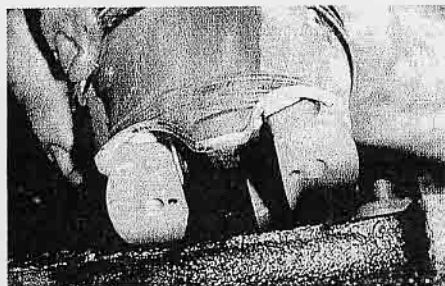
Pistons and con rods can then be pushed out from below. Ours were almost new.
